Development of a Lightweight Truck Mounted Attenuator July 1983

California Department of Transportation

Final Report

Federal Research Grant No. D-4-163

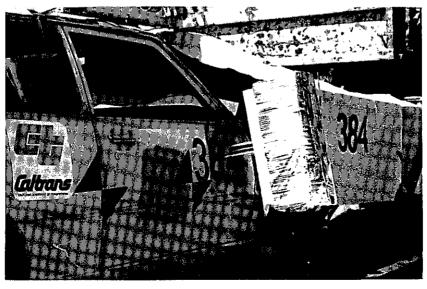
Car Impacted on Center Line

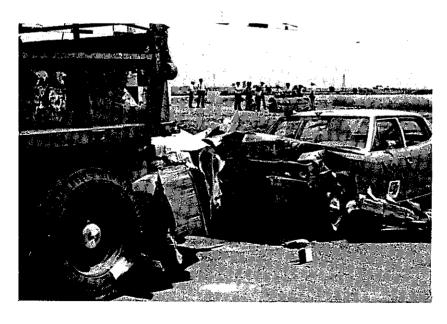
TMA Completely Crushed, 74-Inches

TMA Damage - 386: Ninety percent of the honeycomb cells was damaged during the impact. The lightweight support hardware did not fully support the last cell section. This resulted in the cell shearing at the narrower width of the backup support. This caused the TMA to come apart and honeycomb cell material to scatter about the impact area. Although the test results were acceptable, the backup support was redesigned to provide full width support for future tests. The mechanisms to raise and lower the TMA were not damaged.

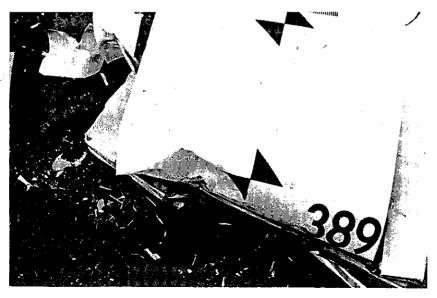
The Car Crushed 24-Inches on the Right Side

Car Damage - 389: Damage to the front of the car was confined to the right front corner. The right front of the car was crushed back 24-inches, the left front was not crushed back. The radiator was crushed back to the fan. Engine position was unchanged. Doors and door posts were not damaged. The roof above the right door post was crimped. In the interior, the right side of the dashboard was slightly deformed. The windshield was intact. All tires were intact. The car required towing from the impact location.

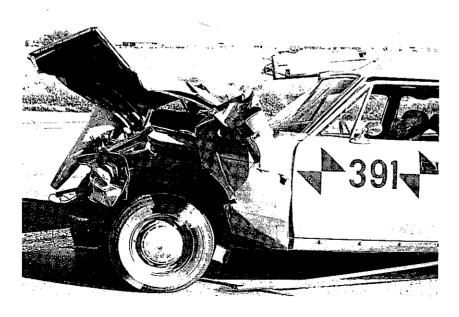
Car After Impact

Car Damage - 391: Damage to the car was very severe. All damage was from the rear doors forward to the front of the car. The unitized frame components were buckled below the engine compartment. The radiator was crushed back to the fan. The hood attachments broke loose. The hood impacted and broke the windshield. The front fenders were peeled back 3 to 4 feet. The doors and door posts were not damaged. The underside of the dash was damaged from the dummy's knees. There was some buckling of the floorboards. The car required towing from the impact area.

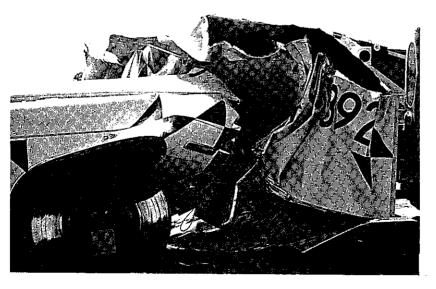
PMA Crushed 59-Inches Car Crushed 7-Inches

PMA Damage - 392: Ninety percent of the PMA was crushed during impact. The car penetrated the full width of the PMA. There was no damage to the support hardware of the PMA.

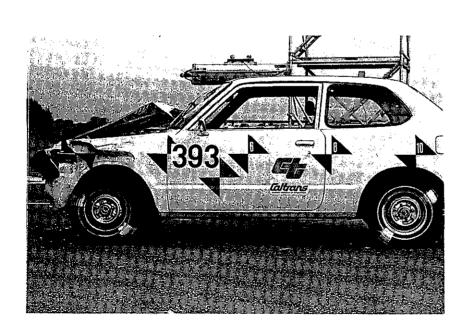
Car Damage - 393: The front of the car was crushed back 8-inches. The radiator and battery were moved back to the transverse mounted engine. All damage was forward of the front doors. The rear opening hood opened and broke the windshield. The doors were not damaged. In the interior there was minor damage to the dash from the dummy's knees.

Car Crushed 8-Inches
